Category	<input type="checkbox"/> New Product <input type="checkbox"/> Maintenance & Service <input type="checkbox"/> Updates of Software <input checked="" type="checkbox"/> Updates of hardware <input type="checkbox"/> Other		
Products	AXH-E230RS	Issue No	ATB-1811001
Client	Taiwan CGA	Issue Date	Nov, 2018

1. Mechanical design change and recall for reaping for the CGA 8 AXH-E230RS UAS.

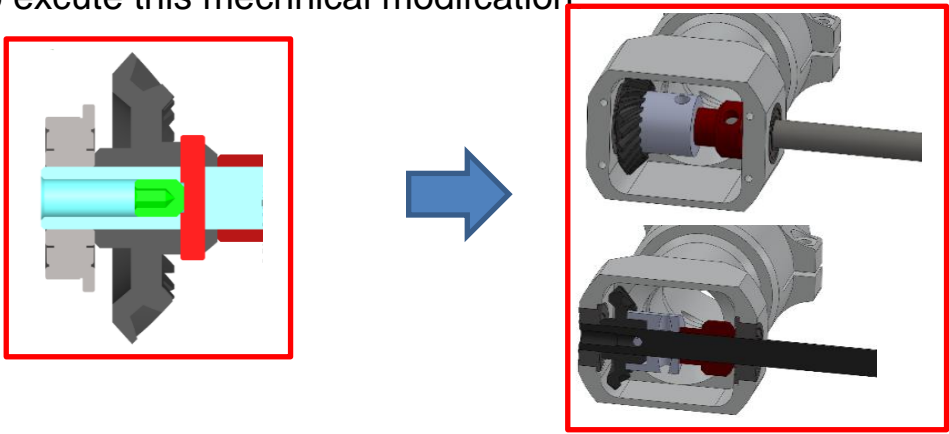
1) On 20th Oct. 2018, the CAG drone - (#CAG-N01) was spin carsh during the hovering status. After careful investigation from the AP download data and crash machine, the reason was found to be due to improper assembly of the tail bevel drive mechanism. (Refer the AVIX report - AQR-181020)

2) In order to prevent the similar human mistake to cause this flight issue, AVIX decided to change the tail rotor drive mechanism. Refer the following pic. to get more detail of the design change.

3) For all the 8 sets of AXH-E230RS that AVIX already deliver to CGA, AVIX will recall to excute this mechanical modification
