Category	<input type="checkbox"/> New Product <input type="checkbox"/> Maintenance & Service <input checked="" type="checkbox"/> Updates of Software <input type="checkbox"/> Updates of hardware <input checked="" type="checkbox"/> Other (Intensive Training Courses)		
Products	AXH-E230RS	Issue No	ATB-1811001
Client	Taiwan CGA	Issue Date	Nov, 2018

1. Arrangement of more intensive training courses to the Coast Guard UAV team for the landing operating on the vessel.
2. Revised the Auto-Pilot firmware to V1.3.294 AVIX.

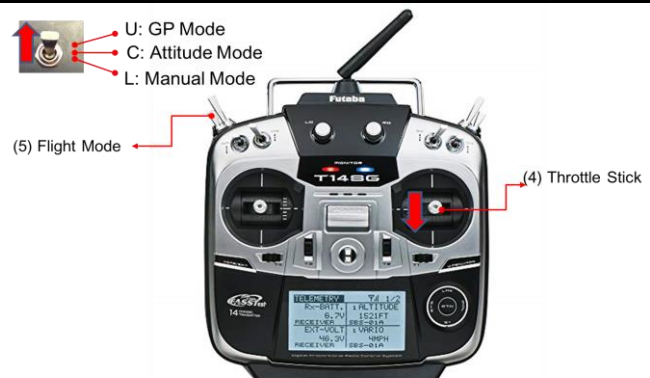
- 1) On the UAV landing of ship deck executed by the crew members of CGA (South Branch) while operating the UAV's flying training course on 11th of Jan., 2019, the main rotor hit the tailboom and caused some damages to the drone. After careful investigation on the AP downloaded data, the main cause of the incident was: when the drone landing on the unstable deck due to the rough sea wave, though the flight controller throttle stick had been pulled to the lowest, the huge height difference of the deck misled the AP to judge the drone had not yet landing and thus fail to power off the drone. Apart from this, the drone was changing its pitch forward due to the rolling ship caused by waves, the flying system thus interrupted with commanding a backward pitch to the drone, and as a result, the main rotor hit the tailboom. (Relevant report please refer to AQR190111)

- Landing process SOP on the vessel
- 1) Pull Throttle stick to the lowest position
 - 2) Pull the light mode switch to the manual mode
